INSPECTION PRIOR TO CUTTING

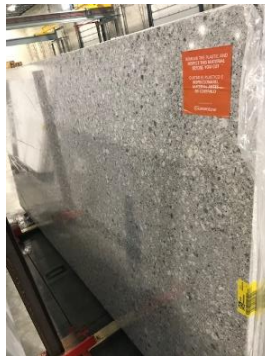
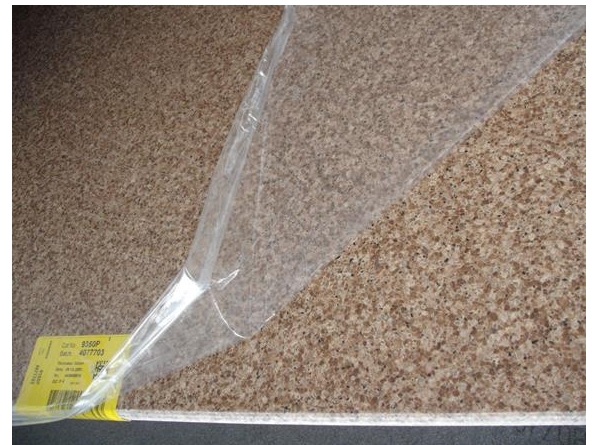
Performing a visual inspection for defects or color matching is essential when working with Caesarstone and should be a standard practice before cutting. Complete the following slab inspection steps as a guide to visual inspection for defects.

PLEASE REMOVE THE PLASTIC PROTECTIVE COVERING PRIOR TO THE VISUAL INSPECTION.

- Hairline Cracks
- Quartz Pattern Irregularity
- Irregular Spots
- Slab-to-slab color match
- Thickness Tolerance 1.5mm
- Inconsistent gloss levels
- Color consistency within sheet
- Warpage: length 1/8" (3mm), width 1/16" (1.5mm)
- Face side pits/voids/blemishes

NOTE: We will not accept any claims for any of the above if the slab is modified in any way whatsoever. The Fabricator is responsible for determining if the slabs are fit for purpose. If they are not, they should be exchanged before the slabs are cut or modified in any way.

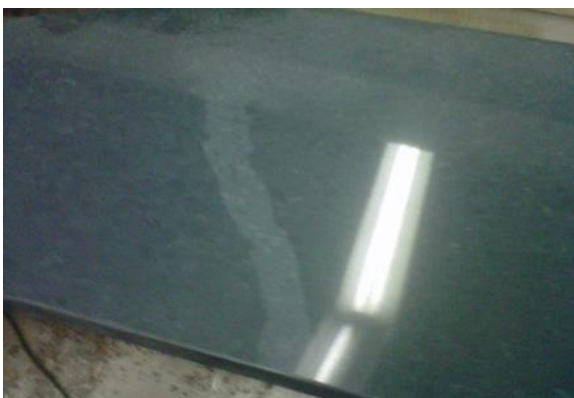
Plastic must always be removed prior to cutting. Cutting material with the plastic in place could allow sediment to become trapped between the material and the plastic, causing it to bond if allowed to dry. This could potentially cause damage or discoloration when removing the bonded sediment.

It is common for plastic to be placed on material after finishing the creation process. Please also use caution when doing final cleaning on the material if it has plastic on it. Any chemical placed between the plastic and the stone will not air dry or flash off and remain moist. This can cause prolonged exposure to these chemicals, which can lead to chemical discoloration.
